**2008 CLEANING AND DEMOLITION PROJECT  
ASARCO EAST HELENA PLANT  
INTRODUCTION, PROJECT SUMMARY, AND REPORTING**

Prepared by:  
**URS Corporation/Cleveland Wrecking Company**  
614 East Edna Place  
Corvina, CA 91723

**March 12, 2008  
Final May 29, 2008**

## 2008 CLEANING & DEMOLITION PROJECT

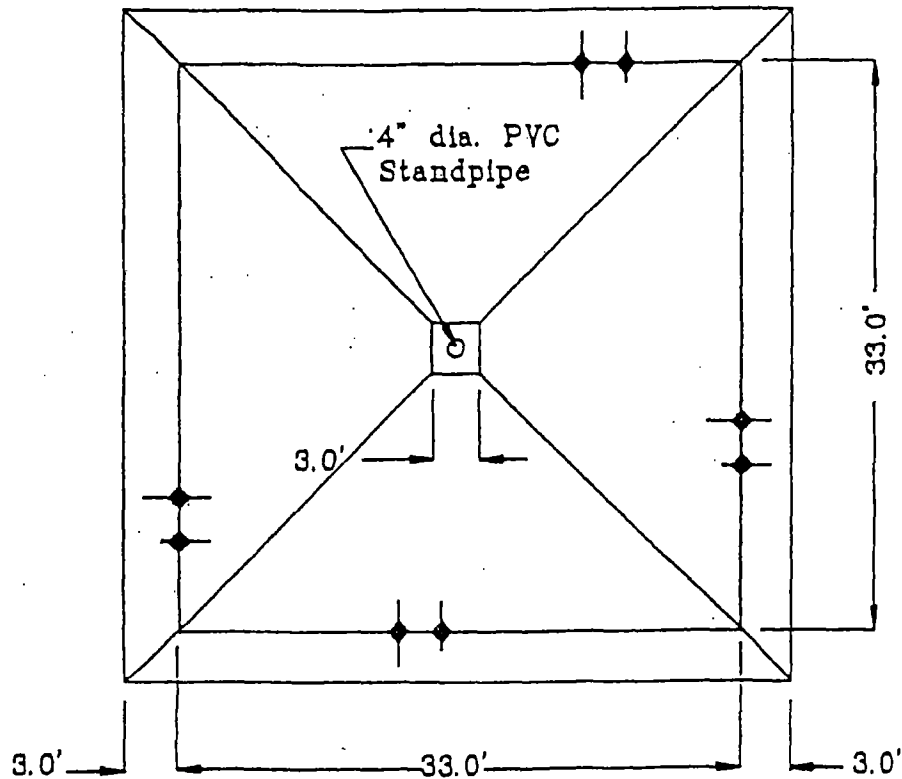
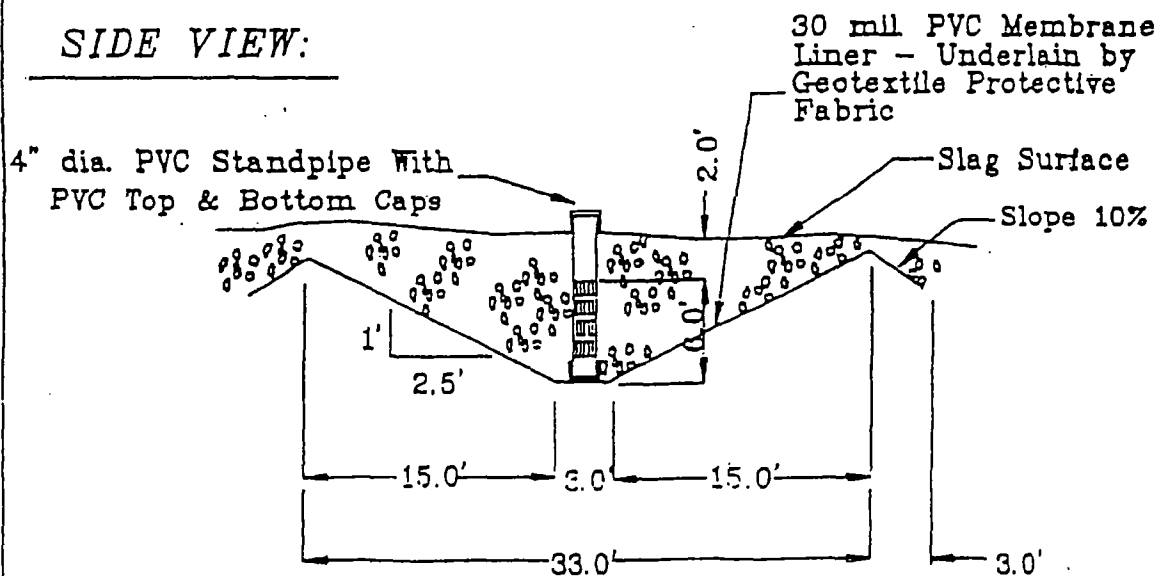
FIGURE 4-1-8 SLAG TEST BASIN DESIGN

Two slag infiltration catchment basins were constructed; one in a typical location in the fumed slag, and one in a typical location in unfumed slag. Construction of the test basins included removal of a 2 to 3 meter layer of slag, placement of an impervious 36-mil reinforced Hypalon liner in the excavation, installation of a collection sump, and replacement of the slag. Figure 4-1-8 shows the slag test basin design.

NOTE: PVC Standpipe is schedule 40, capped on both ends and perforated with saw-cut slots from 2.0' to 8.0' beneath the slag surface.

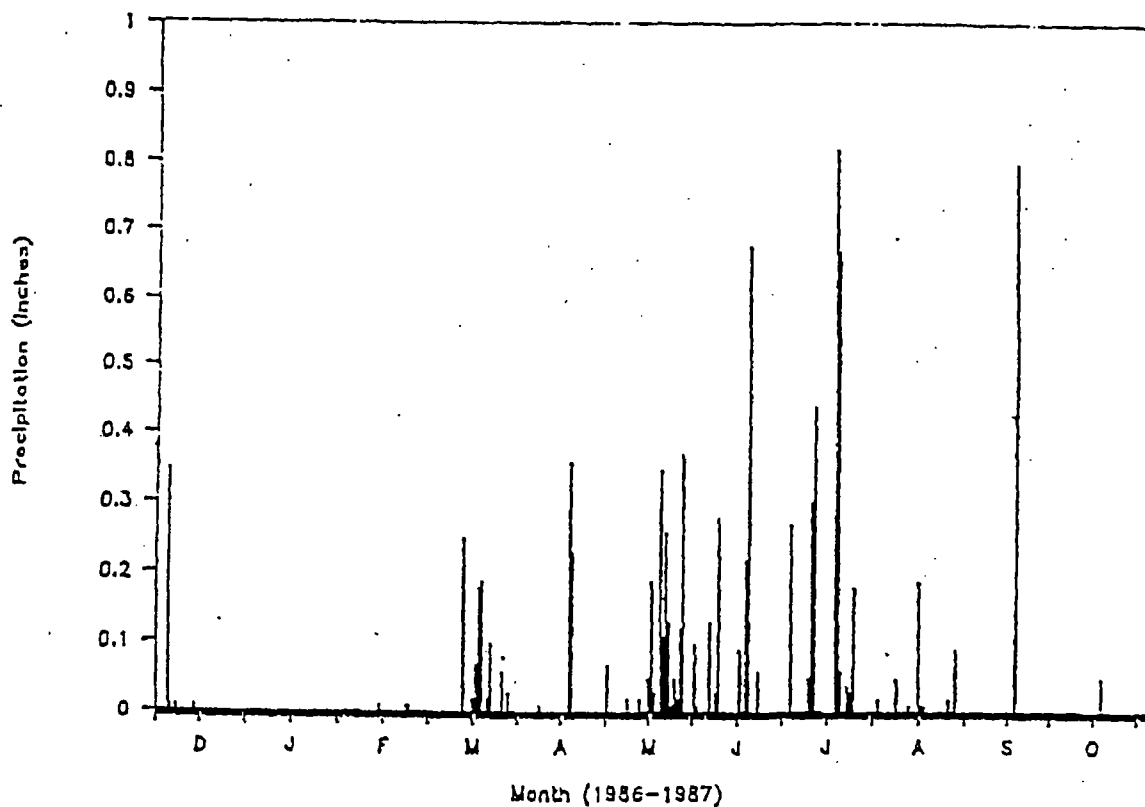
4-1-9

DAILY PRECIPITATION  
AT HELENA AIRPORT

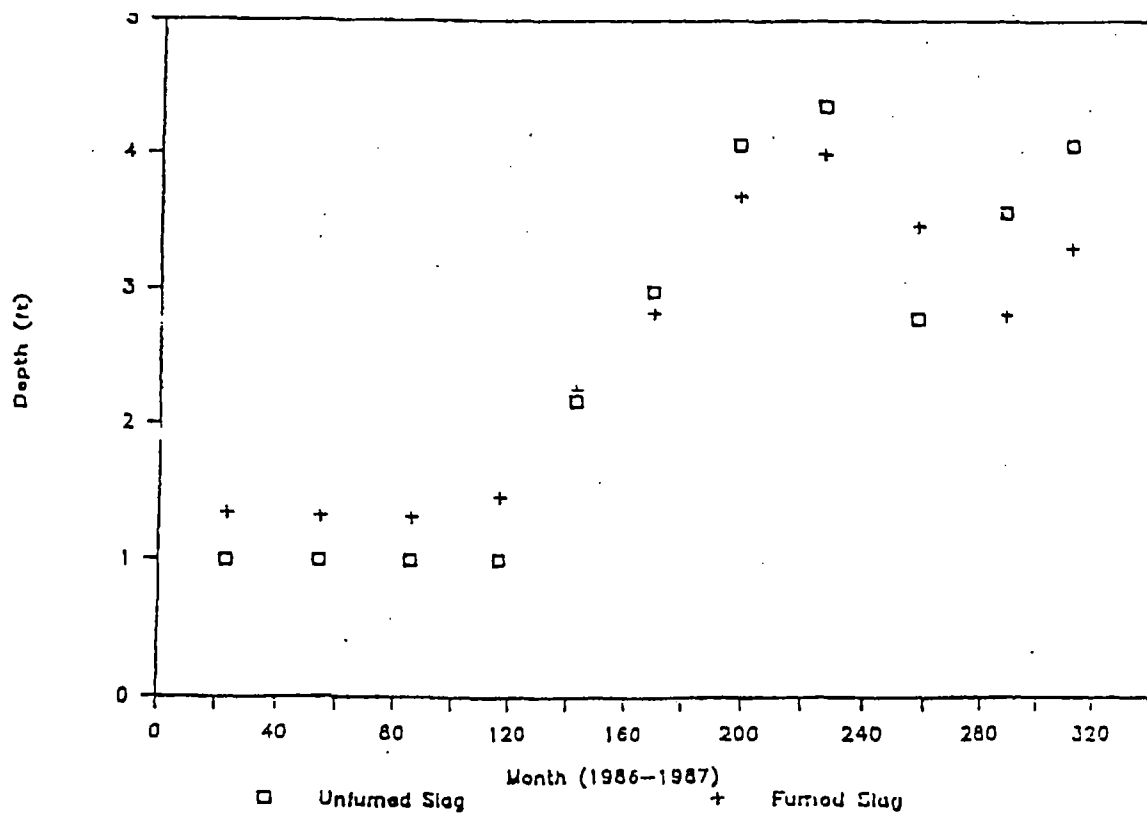
DEPTH OF WATER IN  
SLAG TEST BASIN

In an effort to estimate infiltration rates, the volume of water retained in the slag test basins was calculated for 13 time intervals, beginning December 23, 1986 and ending February 10, 1988. These volumes were compared to the volumes of precipitation during the same periods and converted to percentages, as summarized in Table 4-1-10. The percentage of precipitation retained in the basins varied from -6.7% to 61.9% in the fumed slag, and -45% to 61.8% in the unfumed slag (negative percentages indicate evaporation rates exceed precipitation collected in the test basins). Although there is a relationship of test basin water level fluctuations to precipitation (see Figures 4-1-9 and 4-1-10), the relationship may be complicated by variable evaporation, hence, infiltration rates are variable.

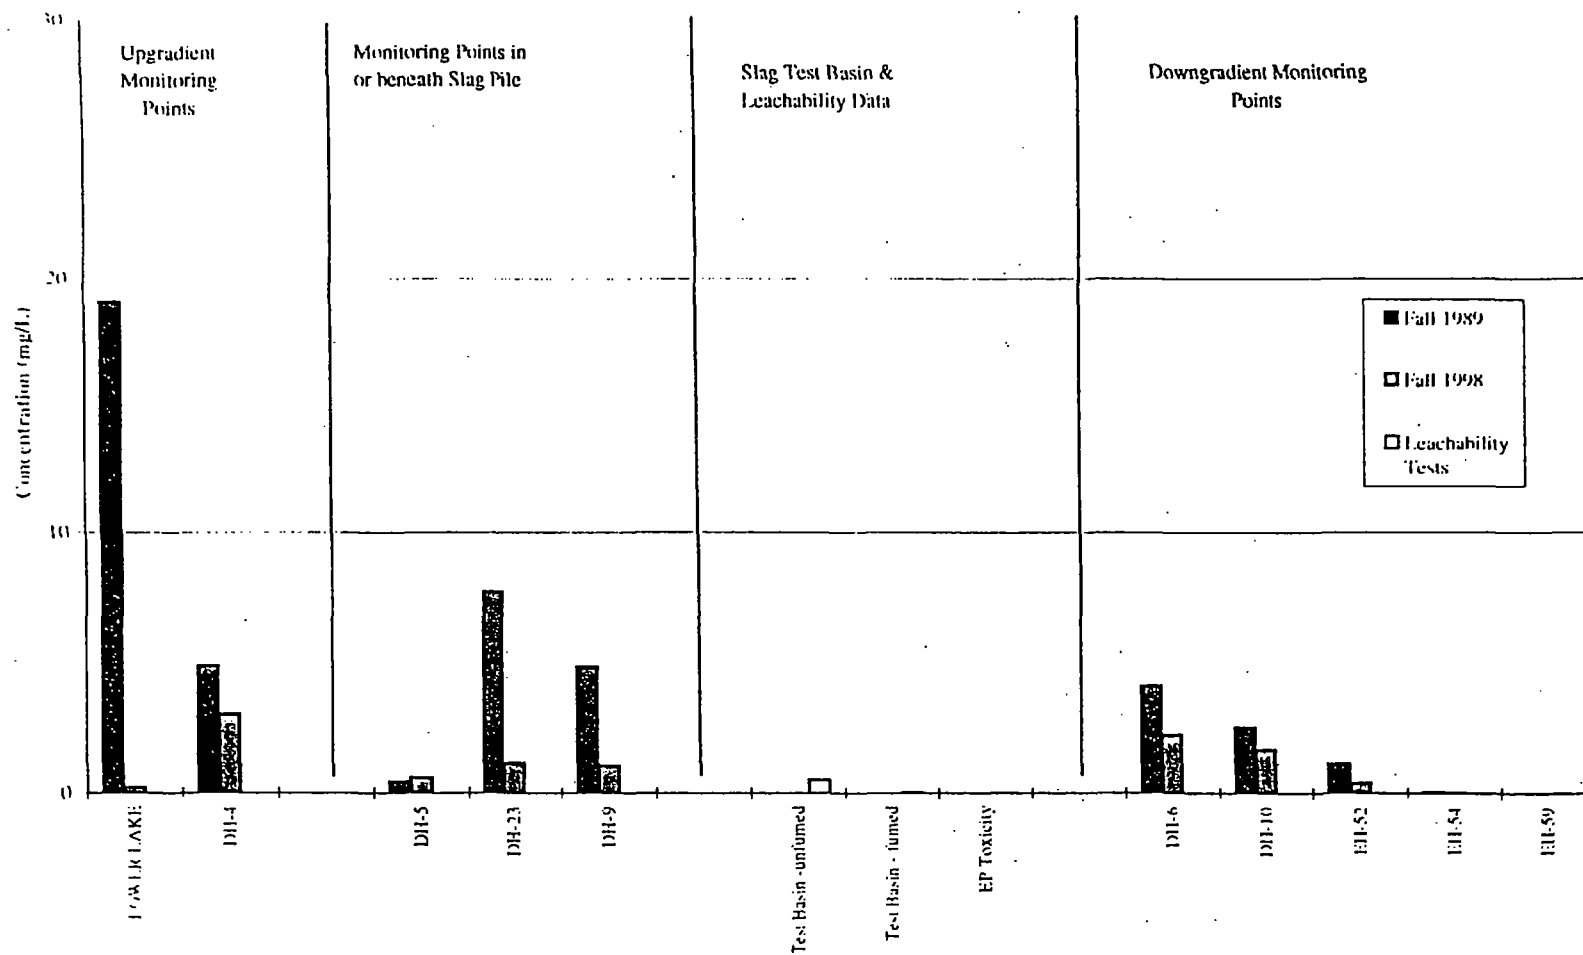
FIGURE 4-1-11. ARSENIC CONCENTRATION DATA FROM GROUNDWATER MONITORING WELLS IN THE SLAG PILE AREA, AND FROM SLAG TEST BASIN AND SLAG LEACHABILITY TESTING RESULTS

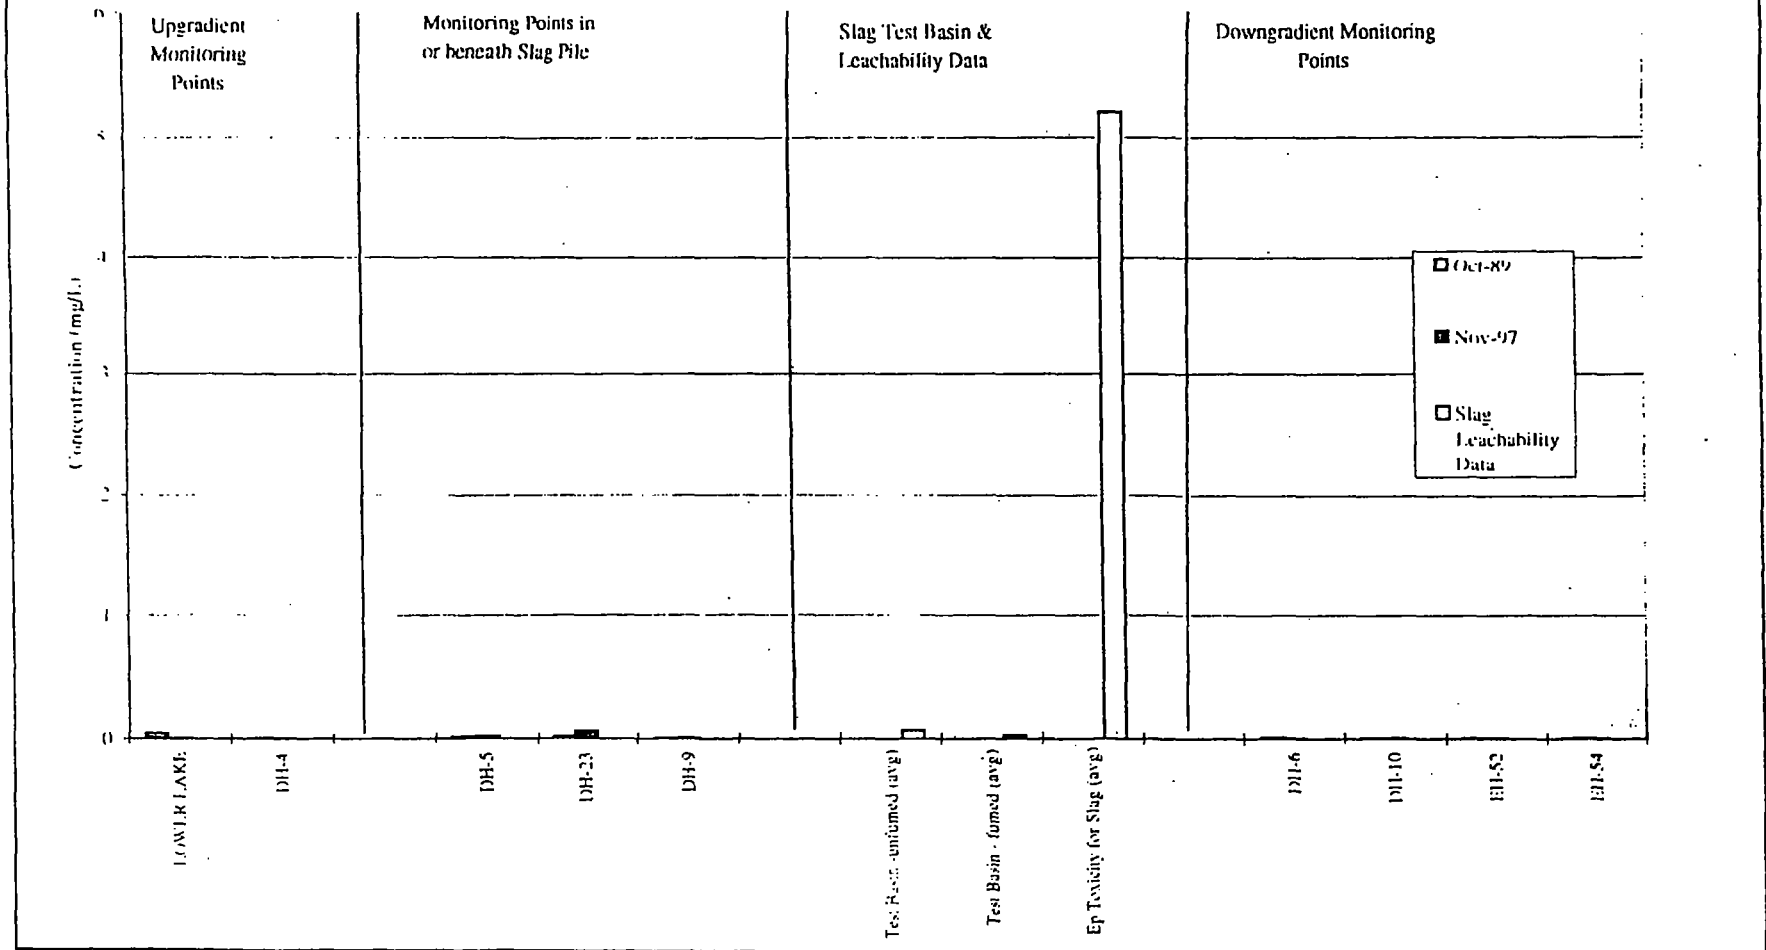
FIGURE 4-1-13. LEAD CONCENTRATION DATA FROM GROUNDWATER MONITORING WELLS IN THE SLAG PILE AREA, AND FROM SLAG TEST BASIN AND SLAG LEACHABILITY TESTING RESULTS

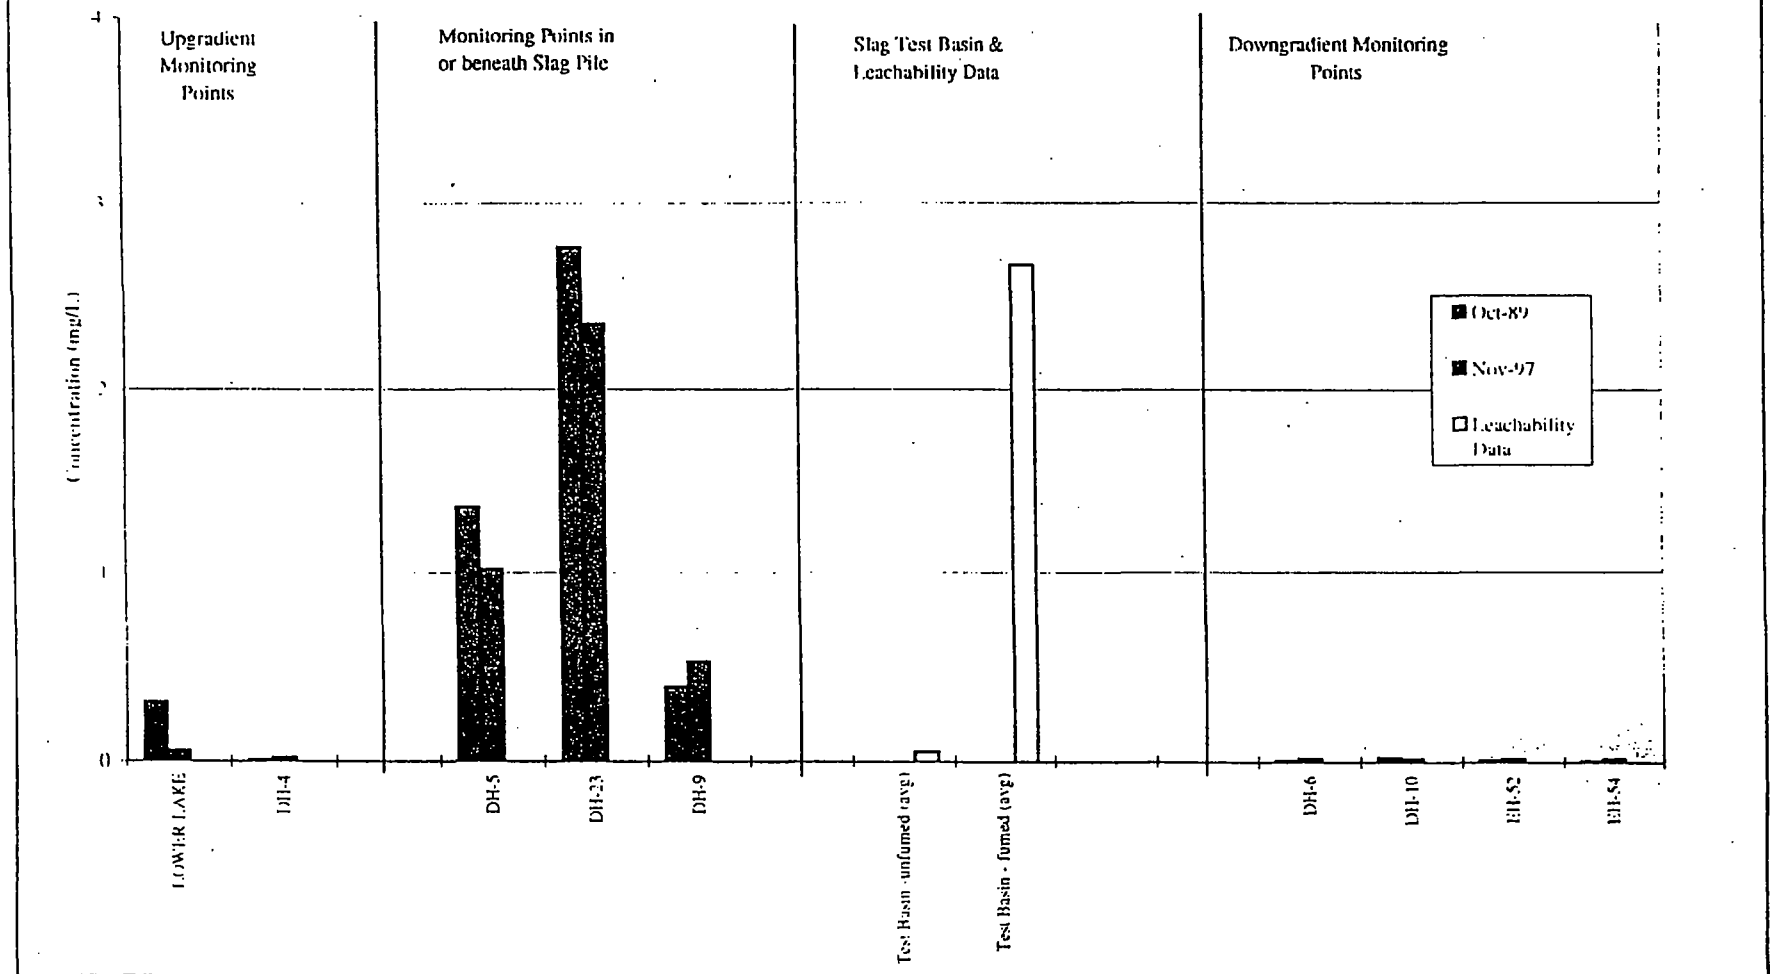
FIGURE 4-1-14. ZINC CONCENTRATION DATA FROM GROUNDWATER MONITORING WELLS IN THE SLAG PILE AREA, AND FROM SLAG TEST BASIN AND SLAG LEACHABILITY TESTING RESULTS

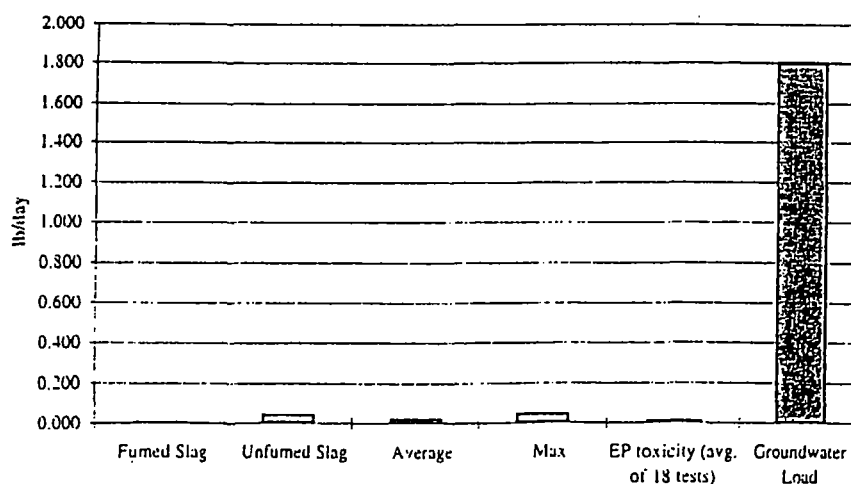
**Arsenic Load**

**FIGURE 4-1-15. CALCULATED ARSENIC LOADING FROM SLAG VS  
ARSENIC LOAD IN DOWN-GRADIENT GROUNDWATER**

(2) Slag load calculations assume:  
20% infiltration (slag test basin average)  
11.3 in/yr ppt  
57 acre slag pile area

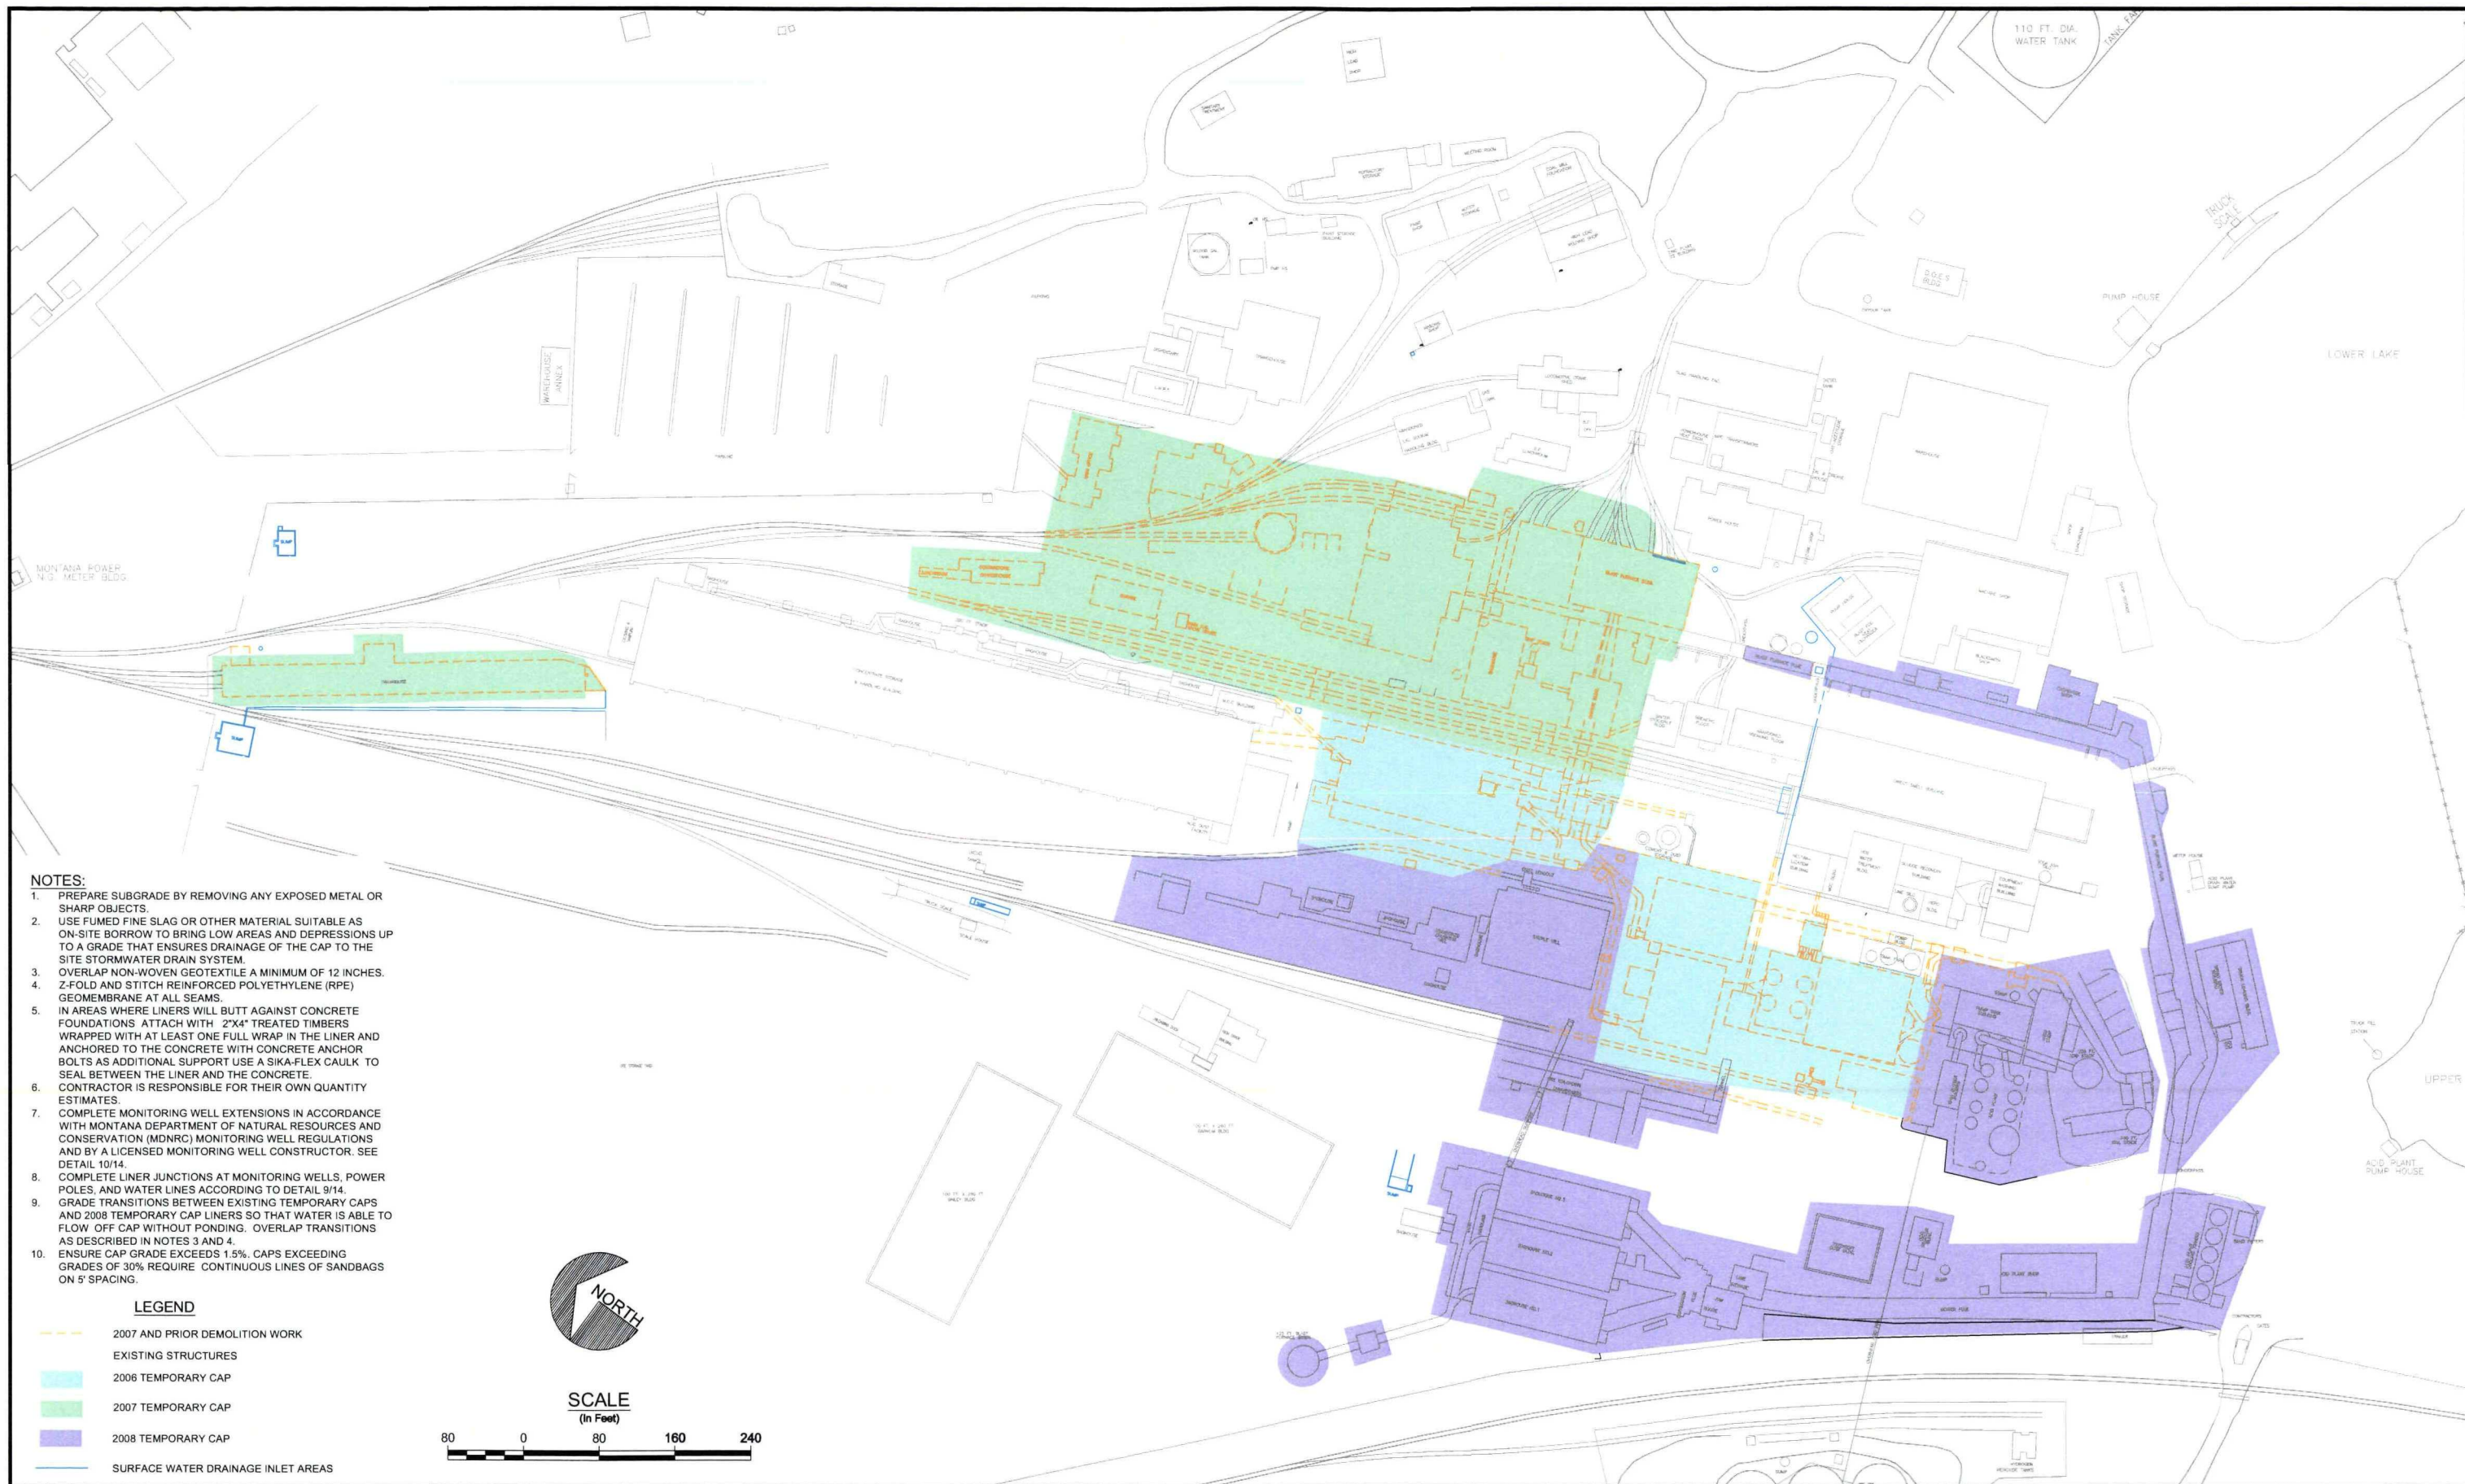
**2008 COVER SYSTEM AND INTERIM CAP - PLAN**

1. PREPARE SUBGRADE BY REMOVING ANY EXPOSED METAL OR SHARP OBJECTS.
2. USE FUMED FINE SLAG OR OTHER MATERIAL SUITABLE AS ON-SITE BORROW TO BRING LOW AREAS AND DEPRESSIONS UP TO A GRADE THAT ENSURES DRAINAGE OF THE CAP TO THE SITE STORMWATER DRAIN SYSTEM.

- Sand bags to hold down the interim cover during windy periods;
- A 24-mil reinforced polyethylene (RPE) with the PRE seams overlapped 3 inches and sewn;
- A minimum 10 ounce non-woven geotextile;
- A prepared sub-grade consisting of fumed slag fill for grading purposes; and
- Existing soils, concrete slabs and/or concrete foundations.

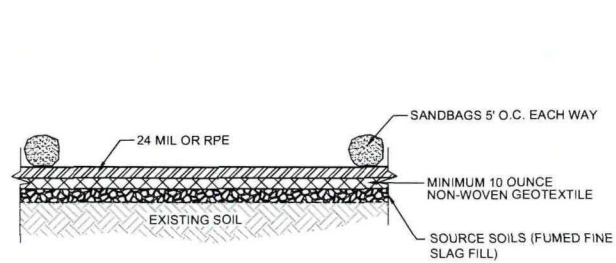
1  
14  
**DETAIL**  
TEMP CAP  
SCALE: NTS

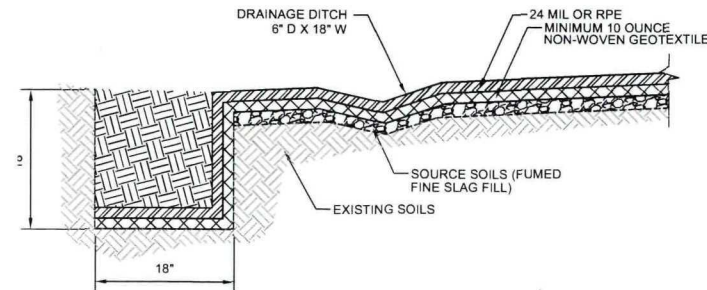
2  
14  
**DETAIL**  
LINER ANCHOR TRENCH WITH DRAINAGE DITCH  
SCALE: NTS

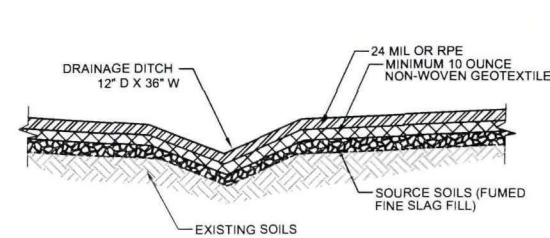
3  
14  
**DETAIL**  
LINER DRAINAGE DITCH (TYP)  
SCALE: NTS

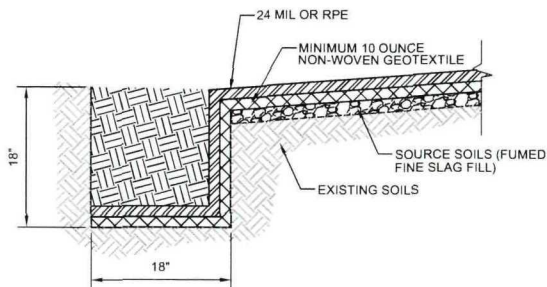
4  
14  
**DETAIL**  
LINER ANCHOR TRENCH  
SCALE: NTS

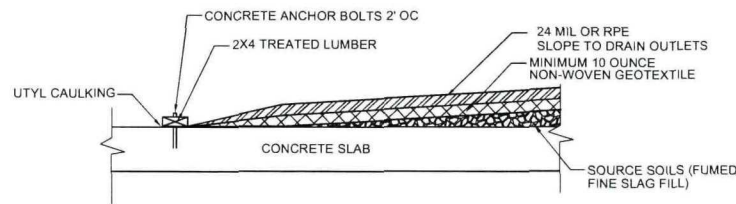
5  
14  
**DETAIL**  
LINER CONCRETE ANCHOR  
SCALE: NTS

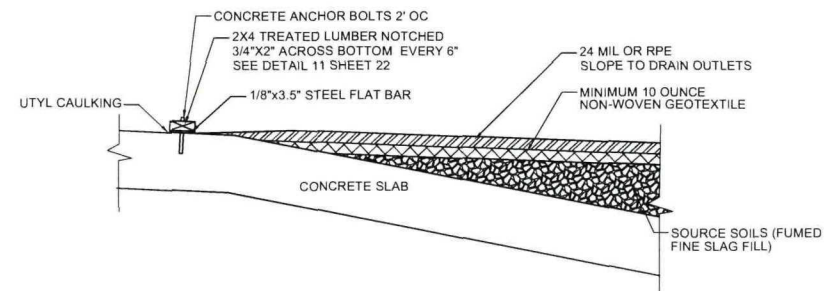
6  
14  
**DETAIL**  
RUN-ON LINER/CONCRETE ANCHOR  
SCALE: NTS

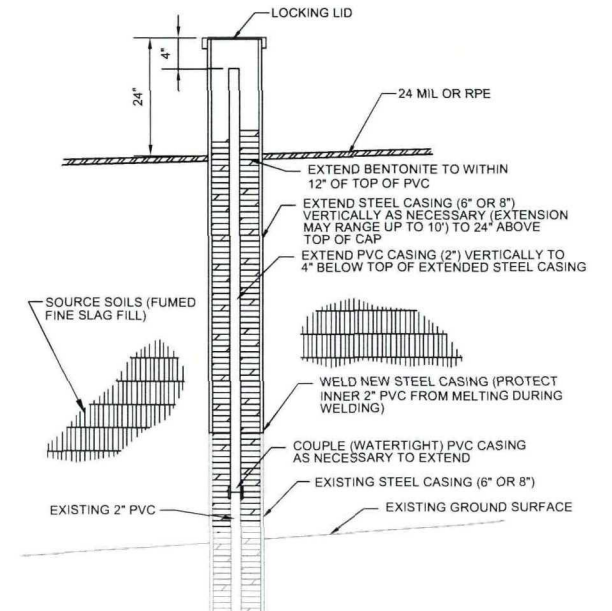
10  
14  
**DETAIL**  
MONITORING WELL EXTENSION  
SCALE: NTS

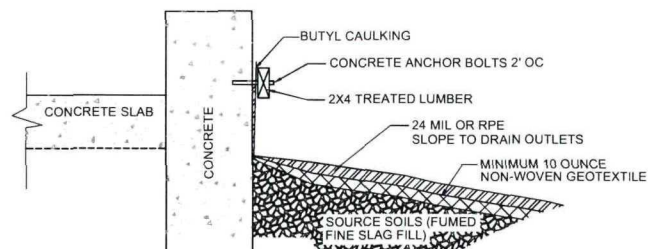
8  
14  
**DETAIL**  
LINER WALL/FOUNDATION ANCHOR  
SCALE: NTS

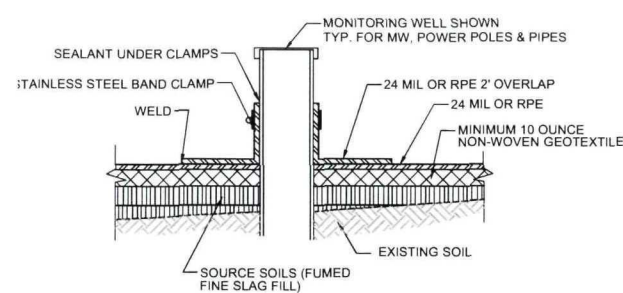
9  
14  
**DETAIL**  
PROTRUSION & LINER CONNECTION (TYP)  
SCALE: NTS

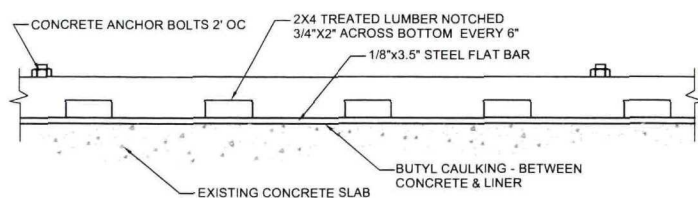
11  
14  
**DETAIL**  
RUN-ON ANCHOR DETAIL  
SCALE: NTS

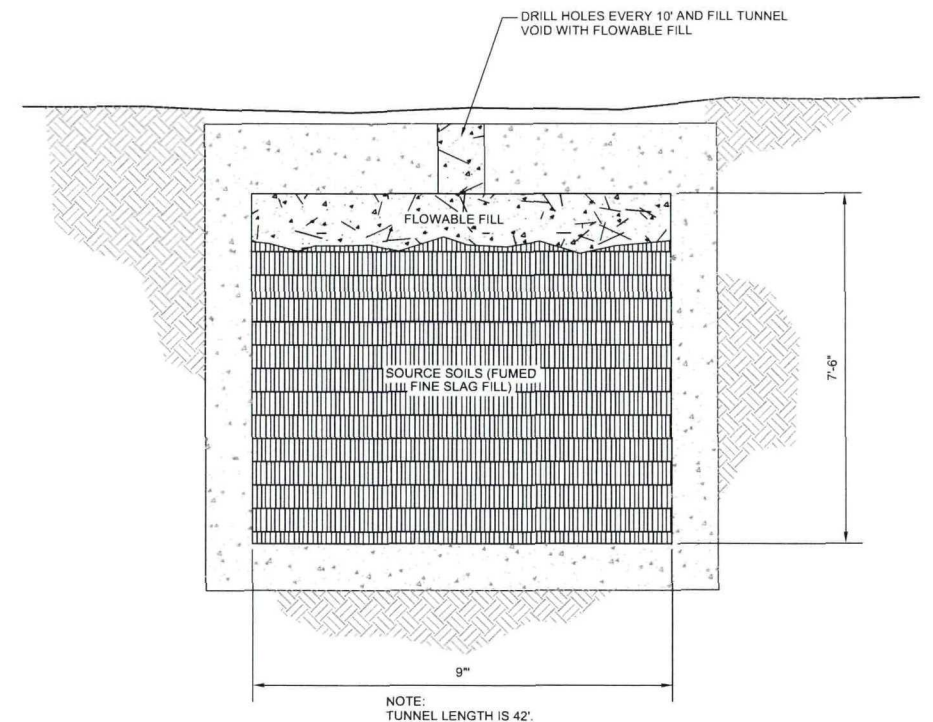
SECTION A  
SCALE: NTS  
14  
**TUNNEL DETAIL**
